FAILURE OF STATIONARY PUMP ENGINE PISTON

Dr Gary G Martin MIEAust CPEng
ATTAR
PO Box 286
SPRINGVALE VIC 3171
www.attar.com.au

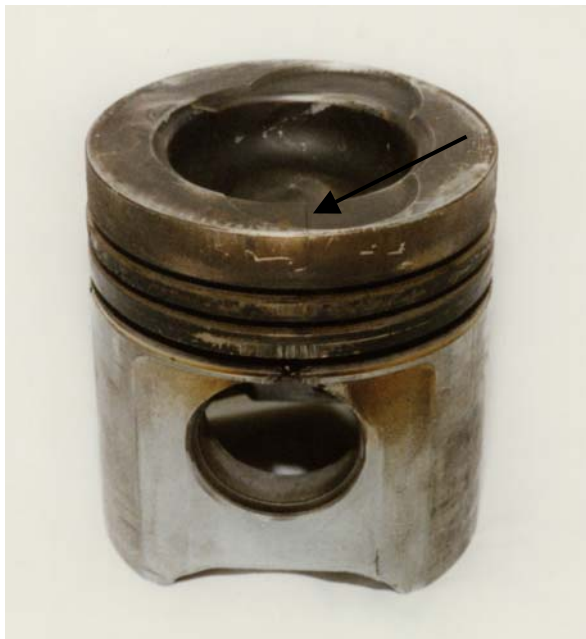
Figure 1. The failed piston with the crack running from the crown down to the gudgeon pin hole.

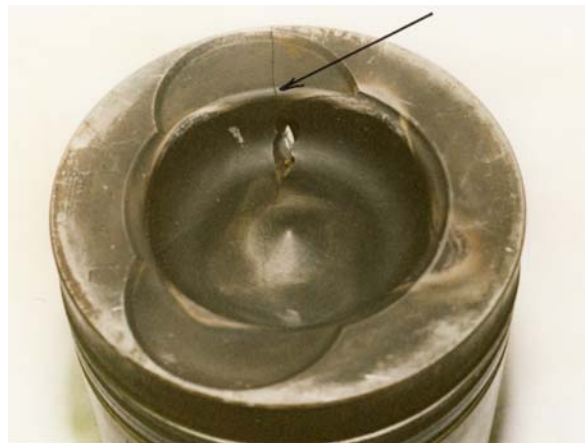
Figure 2. Looking down the hole formed from the combustion chamber to the lower ring. The crack initiated at the edge, arrowed.

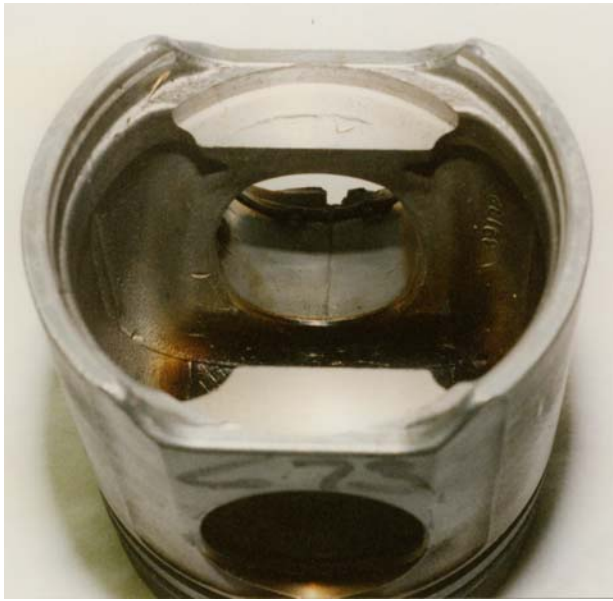
Figure 3. Looking at the top of the gudgeon pin hole with evidence of damage at the third ring.

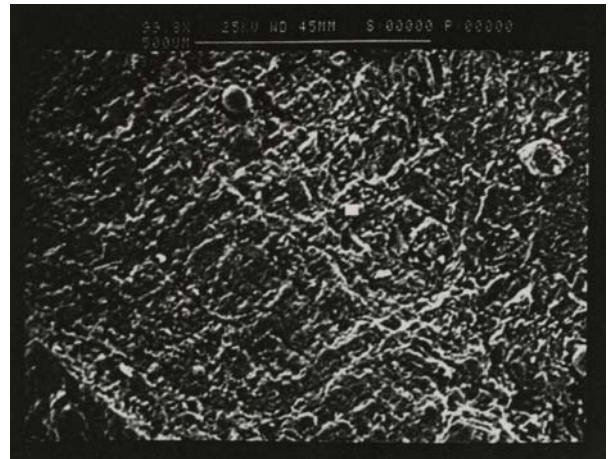
Figure 5. A view of the fracture surface from the SEM showing fatigue markings that have been affected by the hot gasses.

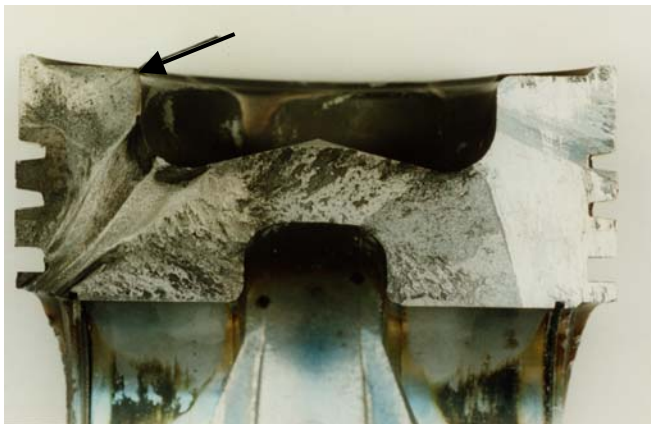
Figure 4. The fracture surface showing the point of fatigue crack initiation, arrowed.

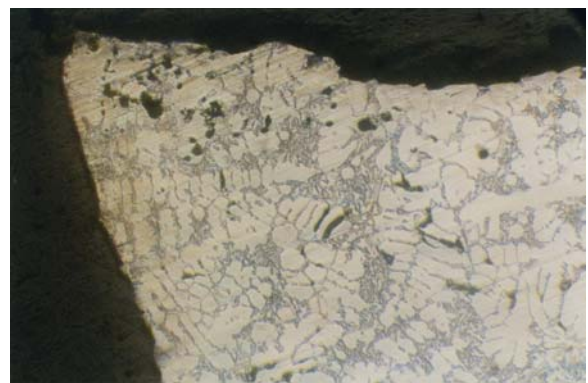
Figure 6. The microstructure at the point of crack initiation showing considerable porosity not evident elsewhere on the section taken.
